Overview of US work on AES003

JLab AES3 Results

R. Geng, AES Meeting at JLab, Aug 2007

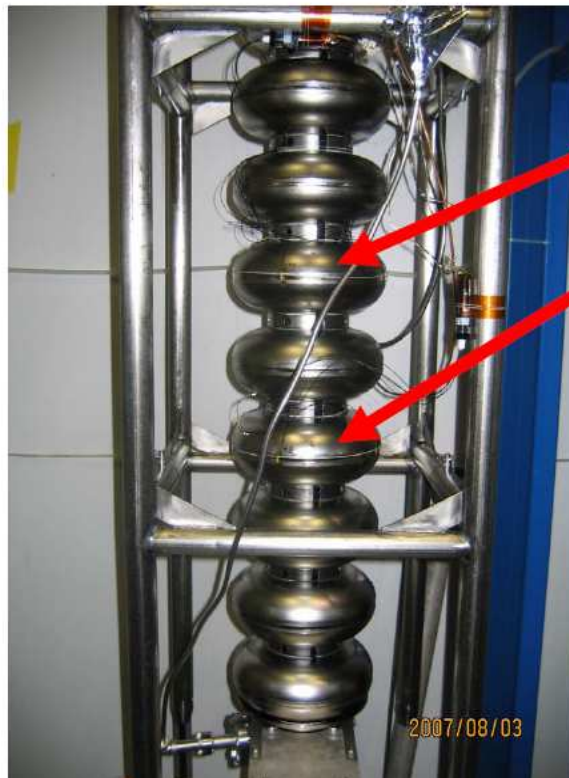
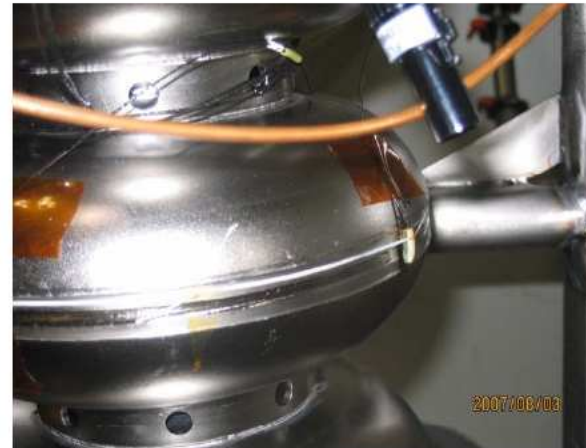
AES#3 2.5th test with thermometry First Step Focused on Equators

Cernox Resistance Temperature Detectors

4 TRD on cell #4

4 TRD on cell #6

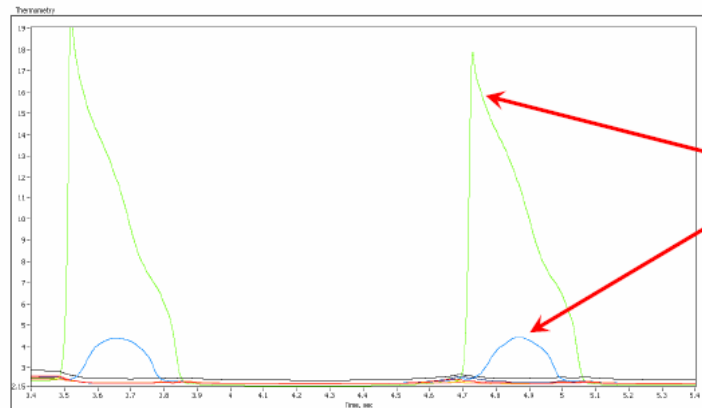
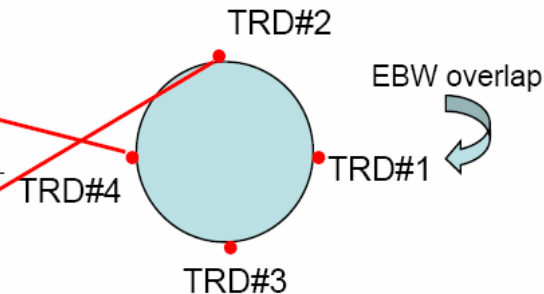
Cell #6 from field probe port reacted,

2K bath: TRD#4 cyclic spike of 20K in synchronism with cyclic collapsing field

Bath above lambda-point: TRD#4 spike also TRD#2

Cell #4 silent

- Cell 6 found responsible for quench.
- Quench location in the 1/4 cell within TRD#2 & 4.
- EBW overlap not responsible.
- Next test more thermometers around TRD#4.
- Goal is to resolve defect location within 3 mm.

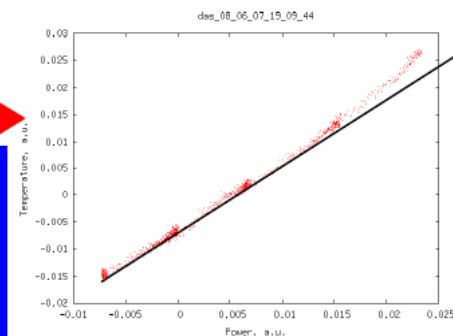
Power sweeping just below quench:
TRD#4 no-linear temperature rise
